PROGRAM SUMMARY

UNICOAT

DEVELOPMENT

LABORATORY CHARACTERIZATION

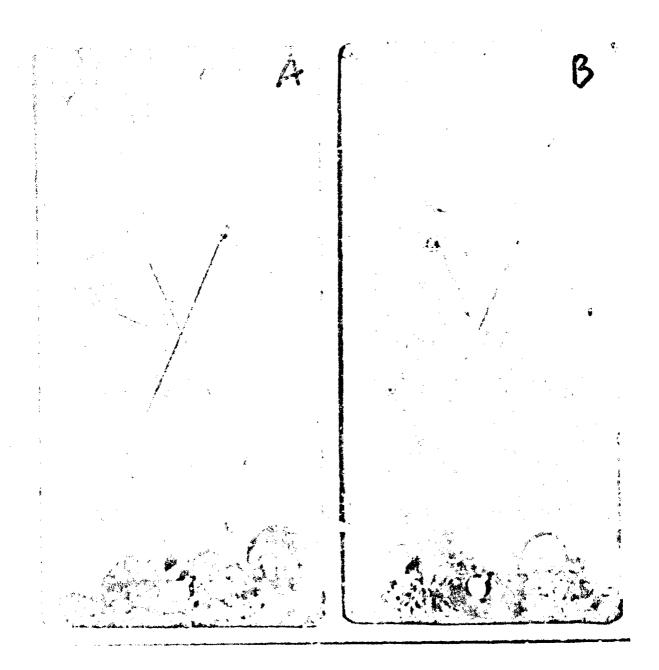
The specified exposure period for Mil-P-23377E and Mil-C-83286B on 2024-T3 in salt spray is 1000 and 500 hours, respectively. However, the primer/topcoat passed this requirement and the exposure period was continued for one year. Figure 4 is a photograph of Mil-P-23377E specimens, Figure 5 is Mil-P-23377E topcoated with Mil-C-832863, and Figure 6 is the lusterlass white primer/topcoat following 2000 hours in 5% salt spray. These specimens exhibited no substrate corrosion or blistering of the coatings. Figure 7 illustrates primer/topcoat specimens following one year in salt spray. Prior to chemically removing the coating in order to analyze the substrate, it was observed that the coating had blistered but was not punctured along the bottom edge of the exposed specimens and at one small area at the upper tip of one of the scribes. On both specimers, corrosion was observed at the areas where the coating had blistered. Due to the extent and location of the corrosion and the duration in salt spray, these results indicate good corrosion protection of the aluminum.

Figure /: Primar/Topcoat Specimens Exposed to Salt Spray for One Year

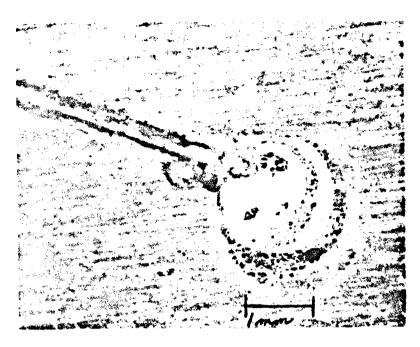
Yellowish deposits were observed in the circular corrosion areas and in the scribe as shown in Figures 9 and 10. These deposits are not grain-like as is usually observed with sodium chloride and aluminum oxide deposits. Chemical analysis of these deposits indicates a large concentration of aluminum and smaller concentrations of chromium, zinc, and molybdenum. Figure 10 is the scribe area of a primer/topcoat specimen after 2000 hours in salt spray. Although the deposits are present on the specimens, they do not cover the entire scribe area, indicating that a build-up of these deposits occurs with exposure in salt spray. Upon further examination, it was determined that there were no pits under these deposits in the scribe area. For comparison, Figure 11 is an NADC flexible primer specimen exposed to salt spray for one year which had no deposits in the scribe. The scribe area of this specimen was shiny, revealing the aluminum substrate.

FIGURE . CIRCULAR AREA ON PRIMER/TOPCOAT SPECIMEN

EXPOSED TO SALT SPRAY FOR ONE YEAR (20X)

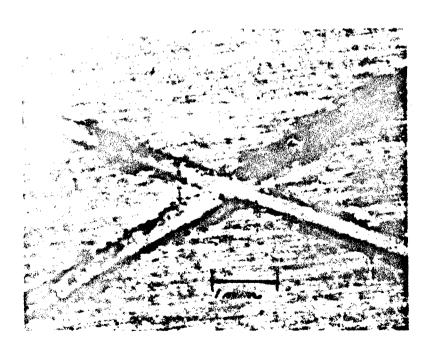
FIGURE . SCRIBE AREA ON PRIMER/TOPCOAT SPECIMEN EXPOSED TO SALT SPRAY FOR ONE YEAR (20X)

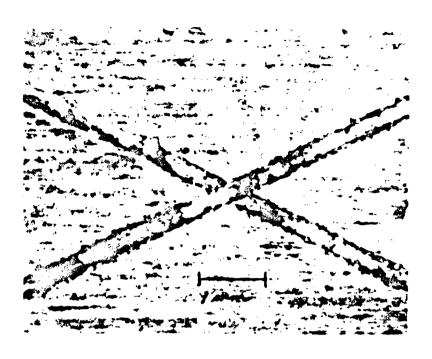
FIGURE . SCRIBE AREA ON PRIMER/TOPCOAT SPECIMEN EXPOSED TO SALT SPRAY FOR 2000 HOURS (20X)

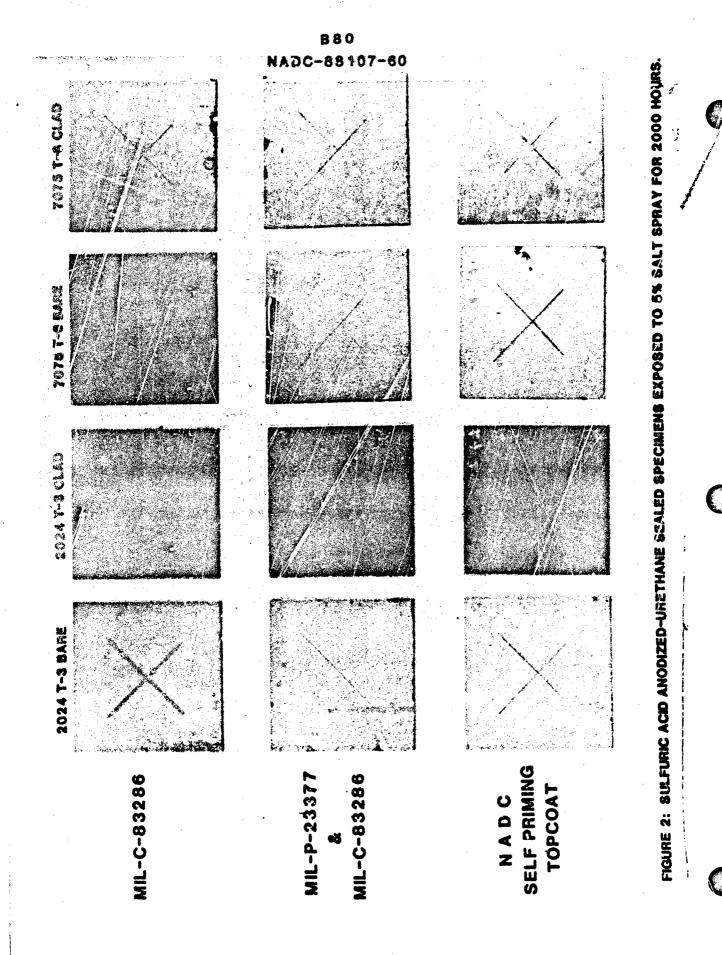
FIGURE 3: SULFURIC ACID ANODIZED-DICHROMATE SEALED SPECIMENS EXPOSED TO 6% SALT SPRAY FOR 2000 HOURS.

The MIL-C-83286 polyurethane topcoat performed well on the dichromate sealed SAA with no blistering or uplifting of the coating and slight corrosion in the scribe area of the 7075 specimens. (Corrosion on the corner of the 2024 T-3 specimen in Figure 3 was the result of an edge effect and was discounted.) The good performance of the urethane on this substrata was unexpected because, aside from the dichromate seal which is damaged in the scribe area, there are no other corrosion inhibitors in the system. The polyurethane topcoat showed some corrosion products and pitting in the scribe of all four substrates treated with the sulfuric acid anodized-urethane seal. Performance on the chromate conversion coated pretreatment was poor. All four substrates showed pitting and corrosion along the scribe and corrosion of the substrata under the coating. We consider superficial corrosion products in the scribe to be acceptable, however any pitting in the scribe, corrosion extending from the scribe, or damage to the coating is unacceptable.

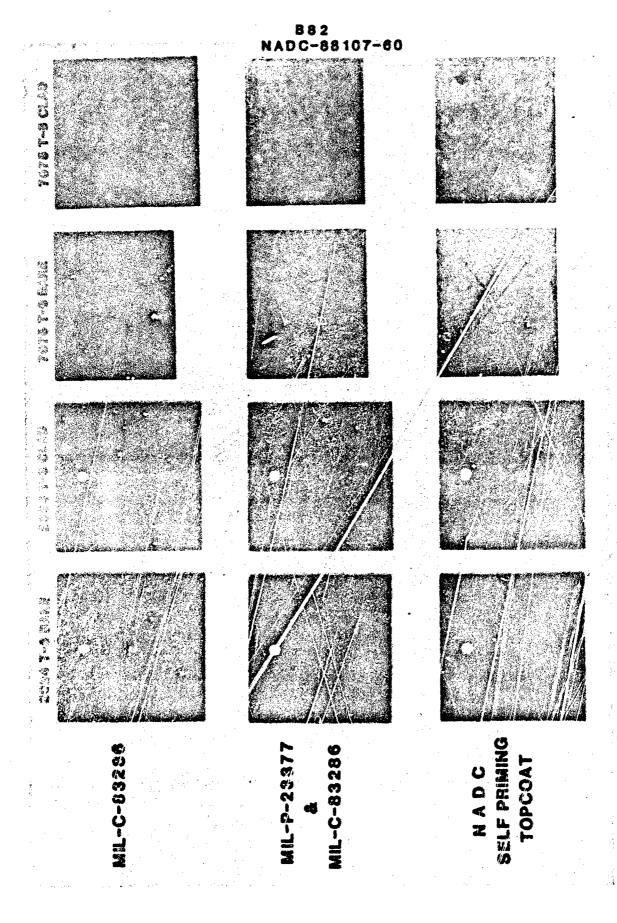
Figure 4: Chriocate conversion coated executens exposed to 6% balt 6pray for 2000 hours.

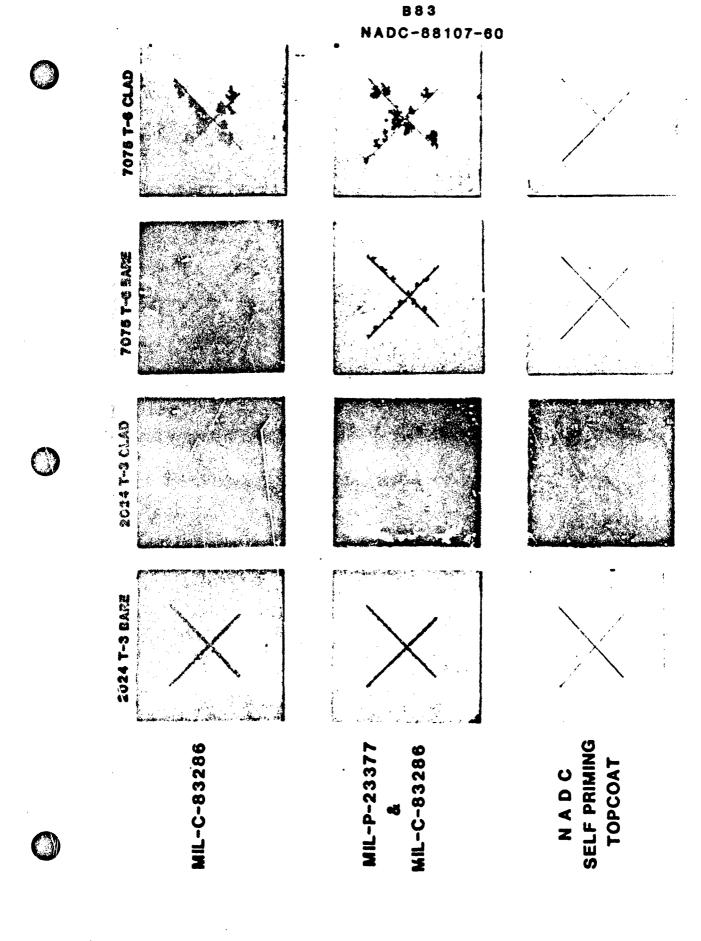
FIGURE 5: SULFURIC ACID ANODIZED-URETHANE SEALED SPECIMENS EXPOSED TO SULFUR DIOXIDE-SALT SPRAY FOR 500 HOURS.

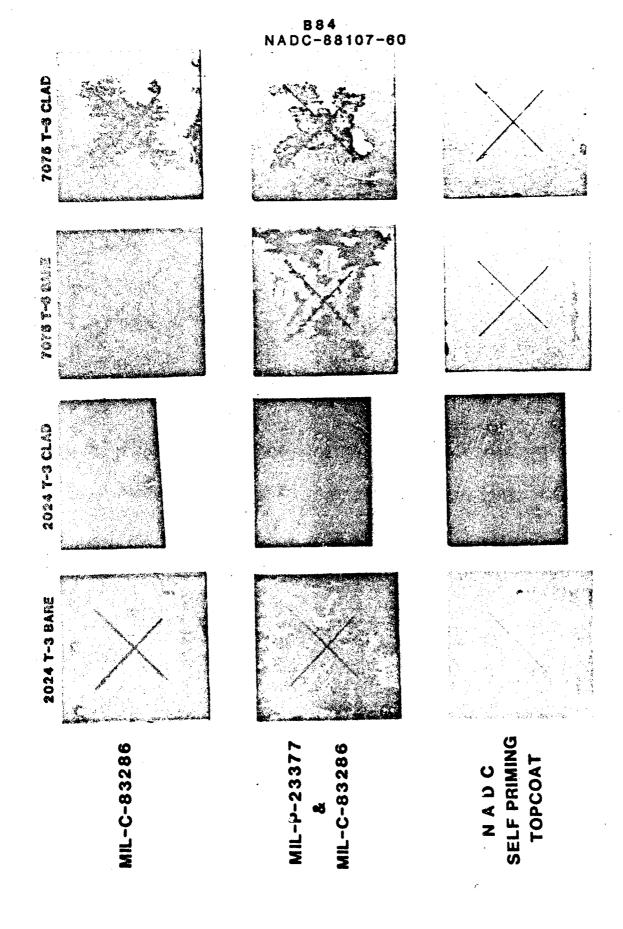
FIGURE 6: SULFURIC ACID ANODIZED-DICHROMATE SEALED SPECIMENS EXPOSED TO SULFUR DIOXIDE-SALT SPRAY FGR 600 WOURS.

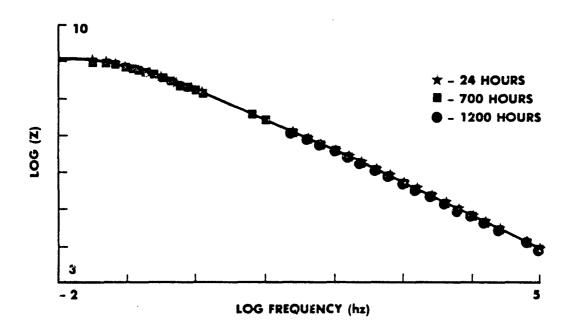
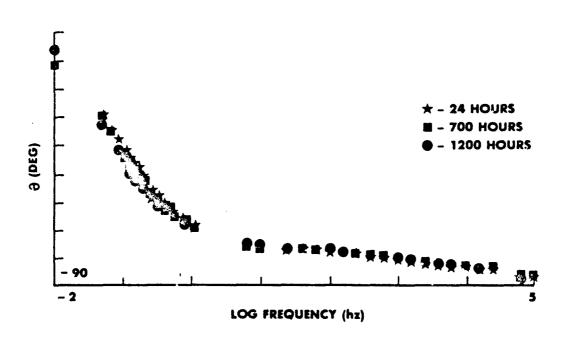
Figure 9. Bode plots for the SPTC system on the bare 7075-T6 aluminum alloy with the SAA/dichromate seal pretreatment at 24, 700 and 1200 hours.

conductivity that provide good barrier protection to the substrates to which they are applied. This impedance value is far above 107 chms which is widely accepted as the lower limit below which no barrier protection is provided by the coating (11). In the high frequency range, the SPTC had phase angles between -80° and -90°. These phase angles also indicate a good barrier coating, where -90° would be a perfect caracitor/barrier. In addition, the shape of the curve for the impedance of the SPTC is virtually straight over most of the frequency range with a negative slope, again indicating capacitive behavior (i.e. good barrier properties). The same results were observed for the SPTC throughout the 1200 hour test duration as illustrated in Figure 9. For all pretreatments, the low frequency SPTC impedance remained above 109 ohms, while the high frequency phase angles continued to exhibit capacitive behavior, remaining between -75° and -90°. There was a small shift in the low frequency phase angle curve for the SAA-urethane/SPTC system over the test duration. The change from capacitive to resistive behavior had shifted slightly to the left (lower frequency) indicating better barrier properties. This change could have resulted from several sources. One possible explanation is decreased micropore size within the coating, caused by swelling of the polymer. However, since the phenomenon occurred with only one pretreatment, this explanation was dismissed. Another plausible explanation is increased coating adhesion. This increased degree of interfacial bonding with time, also noted in reference (12), could have been enhanced or catalyzed by the presence of some electrolyte at the interface. Finally, during the 1200 hour test period, the chemical corrosion resistance properties of the inhibitors in this coating did not come into play and will not be addressed here.

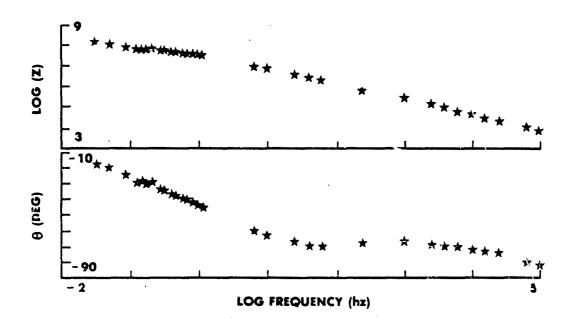
Figure 10. Bode plot of the EP-UR coating system on bare 7075-76 aluminum with the chromate conversion coating pretreatment at 1200 hours.

The primer and topcoat (EP-UR) system on all three substrates had an impedance of 6.3x10⁷ ohms after 24 hours immersion. Again this indicates barrier type properties, however not as good as the SPTC. This lower barrier protection is also apparent in the phase diagram where the phase angles for the EP-UR system were between -60° and -80°, showing less capacitive behavior. The shape of the EP-UR magnitude curve was similar to the SPTC curve, however it was evident at a lower impedance range. The improved barrier protection provided by the Self-Priming Topcoat resulted because this coating was specifically designed to have high flexibility and a smooth surface and therefore it is less porous than the standard epoxy-urethane coating system. In addition, the EP-UR impedance curve leveled off at a higher frequency than the SPTC, indicating lesser barrier properties. Although the EP-UR coating is not as good a barrier coating as the SPTC, it does provide excellent corrosion protection as indicated in the salt spray results and reference (3). The low frequency impedance magnitude of the EP-UR system remained between 10⁷ and 10⁸ ohms and the shape of the curve was similar over most of the exposure time. However at 1200 hours, the chromate conversion coating/EP-UR impedance curve began to show an upward turn after leveling off in the low frequency range as shown in Figure 10. Also, the phase angle curve was beginning to develop a peak in the high frequency range. These two trends indicate the presence of electrolyte at the interface resulting from some adhesion loss. Also, some type of electrochemical reactions were occurring at the interface, probably corresponding to chemical inhibition of the corrosion process by the inhibitors within the primer.

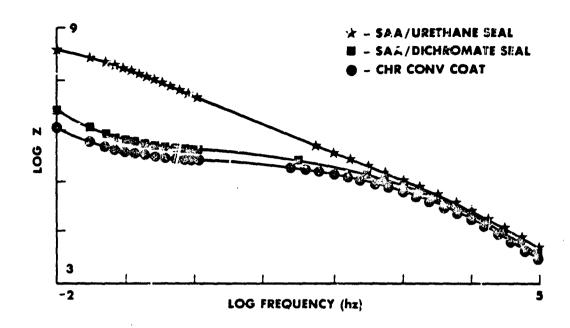
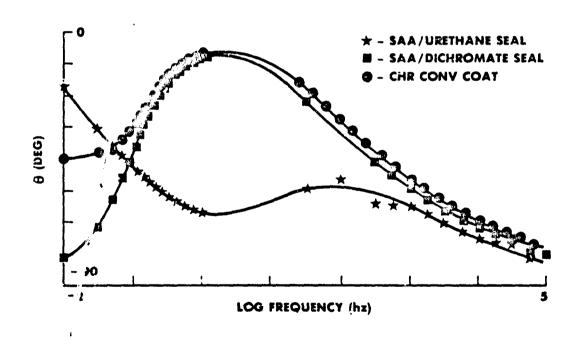
Figure 11. Bade plot of the UR coating on the three pretreatment systems after 24 hours.

The unprimed polyurethane topcoat (UR) performed differently with the various pretreatments. After one day, the UR with the SAA/dichromate seal and the conversion coated pretreatments had low impedance values (1.3x10⁷ and 2.5x10⁶ ohms, respectively) and provided little or no barrier protection to the substrata. Furthermore, unlike the shape of the other two impedance curves, the UR impedance curve leveled off in the mid-frequency range and then began to curve upward at the low frequency range. This behavior corresponds to a porous coating with poor adhesion, where electrolyte is allowed to penetrate the film and accumulate at the coating-metal interface. Finally, the phase angle behavior for these pretreatments was significantly different than the other two materials (see Figure 11). At 10⁵ Hz the phase angle was -80°, however as the frequency decreased, the phase angle reached a maximum of approximately -5° at about 1 Hz. This gradual change from capacitance to resistance then sharply reversed back to capacitance again in the low frequency area. This response indicates a double layer capacitance at the metal surface resulting from the presence of electrolyte at the interface caused by
